International Journal of Innovative Surgery

Open Access | Clinical Image

Rectovesical Fistula after EEA Stapler Misfire During Hartmann's Reversal

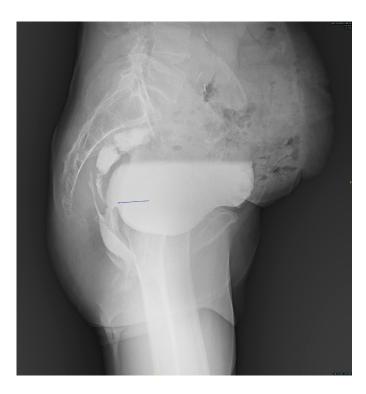
Image shows a retrograde cystogram done in a patient after reversal of a Hartmann's procedure for carcinoma of the rectum. The image shows a fistulous communication between the trigone area of the urinary bladder and the stapled anastomotic site

Patient underwent a second procedure to repair the fistulous site and hand sewn colo-anal anastomosis. He has done well since then.
